# PROCEED General Standards

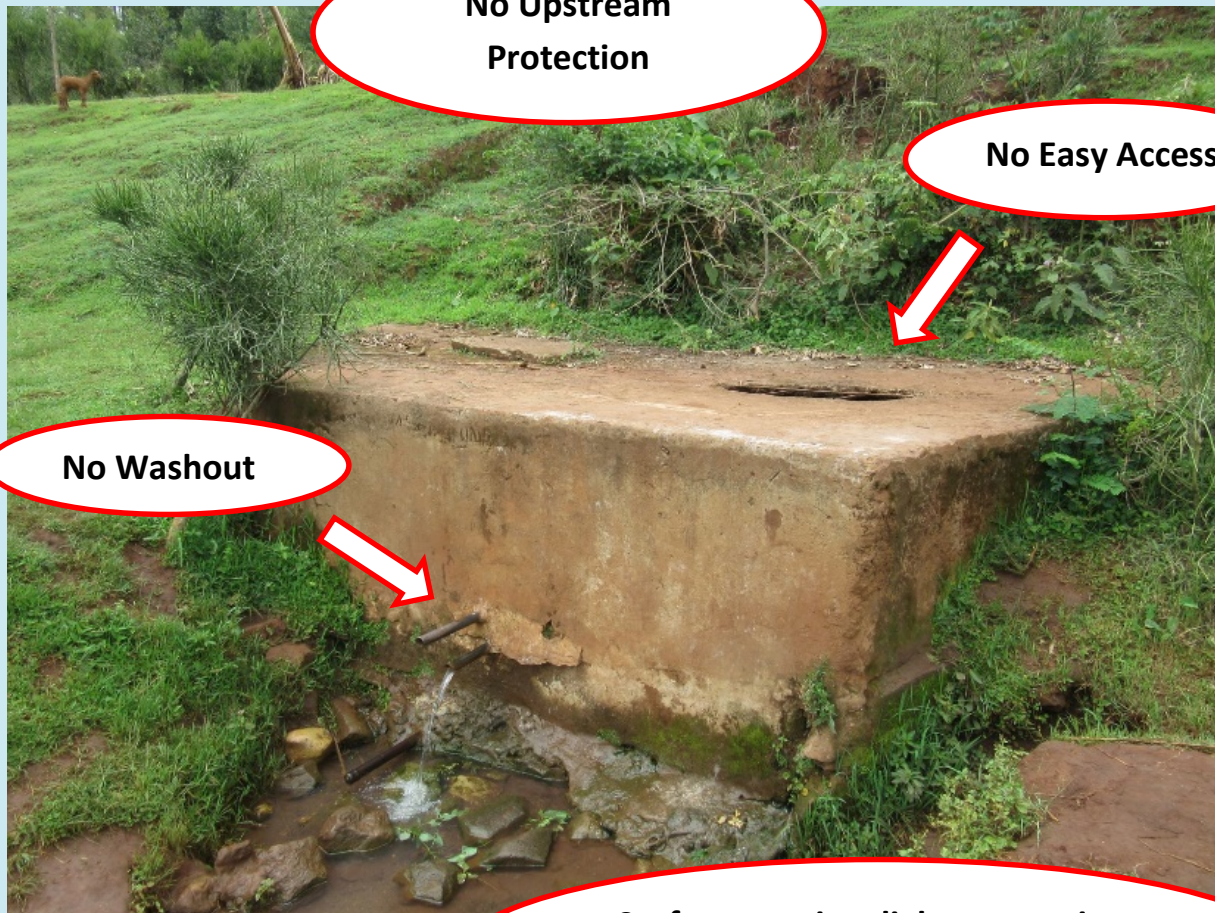
### Frequently observed Weaknesses

Surface capping: light excavation:  
Water quality not guaranteed

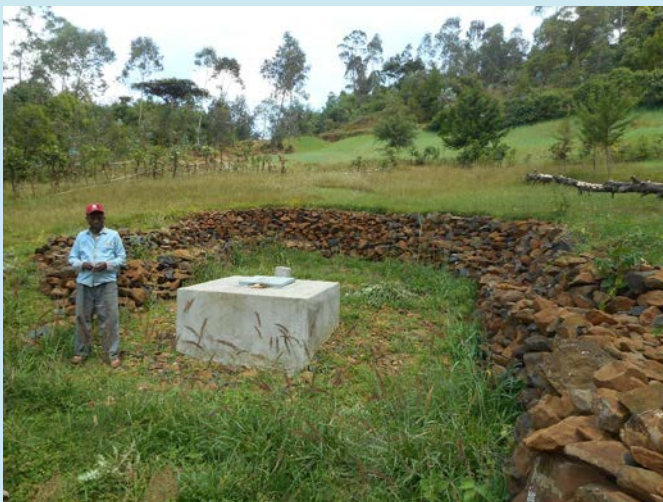
Spring Outside View:  
Close protection and catchment perimeter  
fenced (against animals)

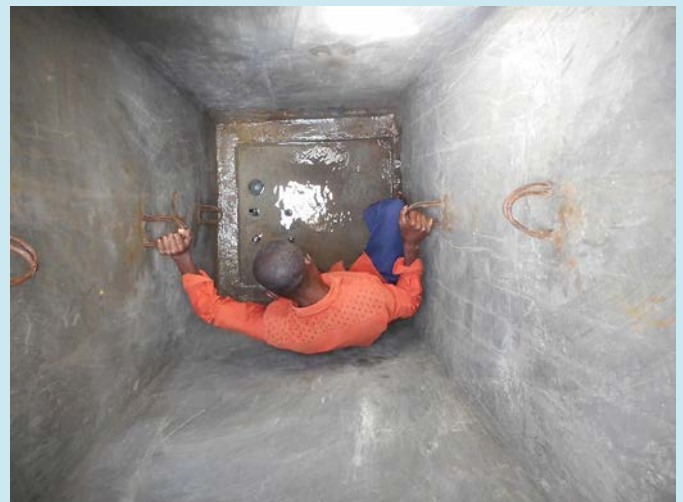
Spring Catchment Box Inside View

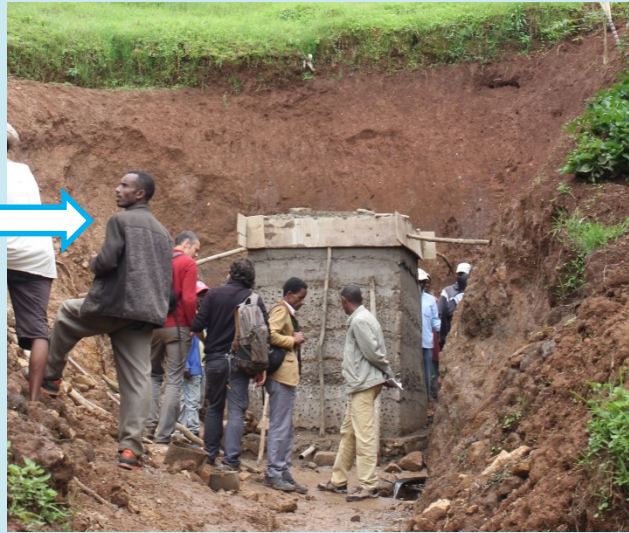
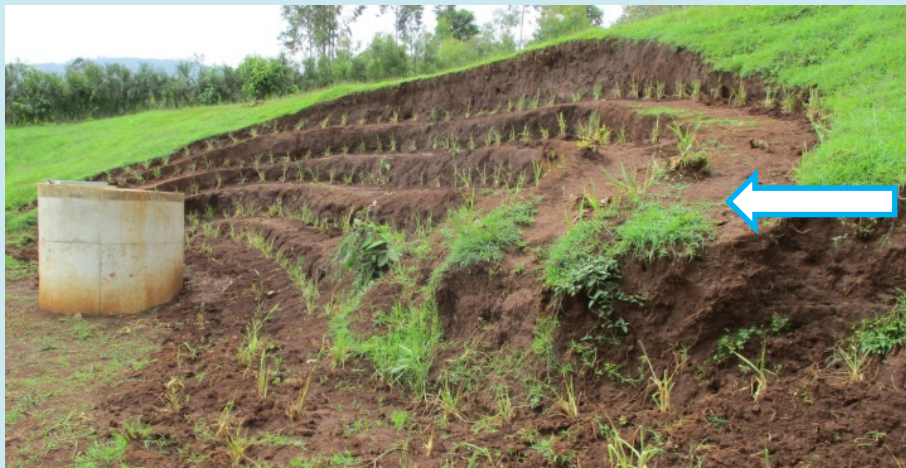
- Deep Excavation to insure:
- Water preferential path is toward spring Box
  - Good spring water quality

Vegetative or  
Constructed upstream  
protection  
(Fence not visible on this  
photo)

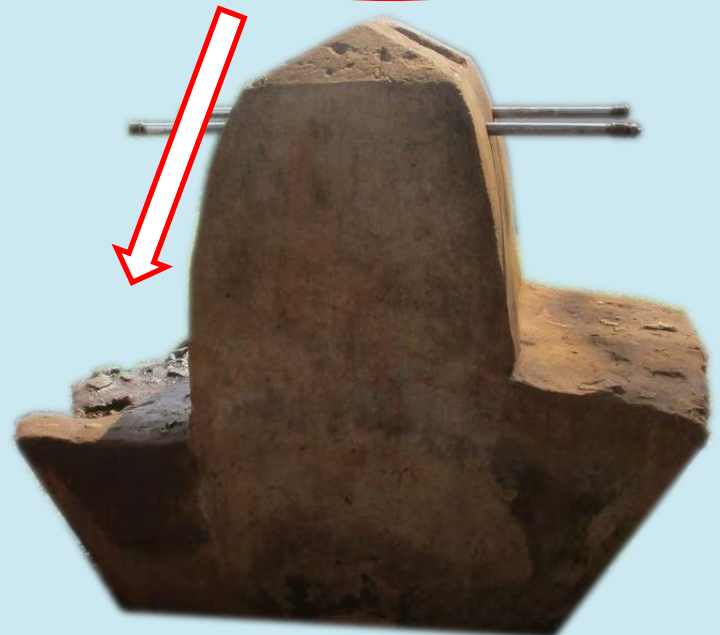
Wash Table for laundry

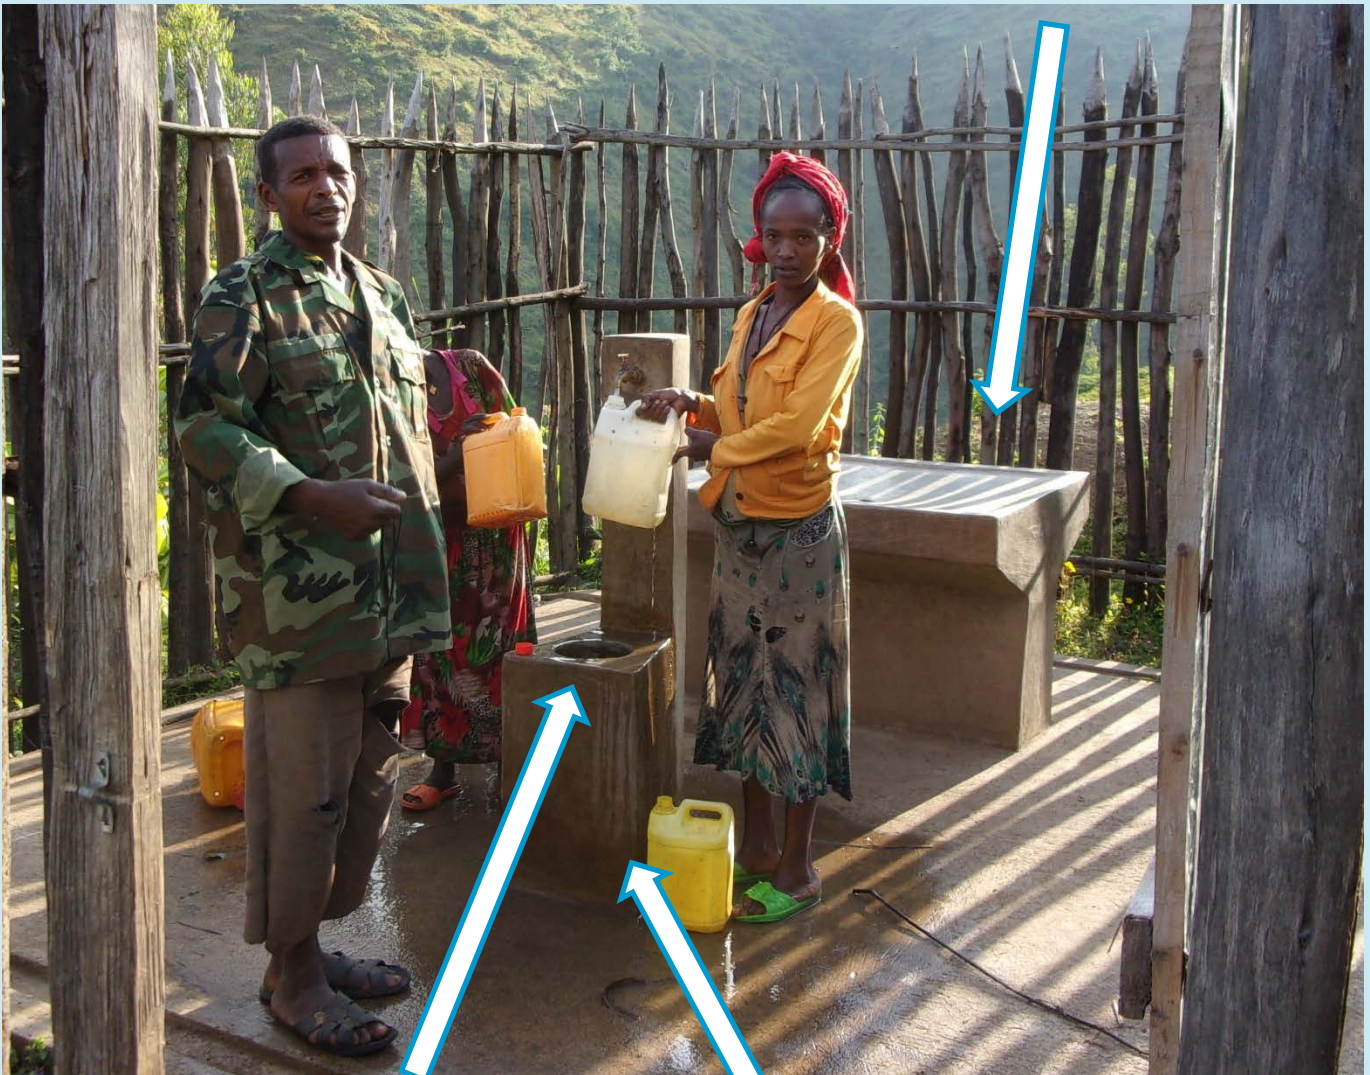
Evacuation funnel to cattle  
trough→  
Clean & efficient reuse of water

**Strong casted concrete construction** →  
Resistant & durable

Access to clean water in cattle  
trough →  
Improved breeding performances
